# Manhole Inspection Summary

Manhole # S37II\_027MH

Insp Date: **3/16/07 8:37 AM**

**Location** Address: **400 PITMAN PL**

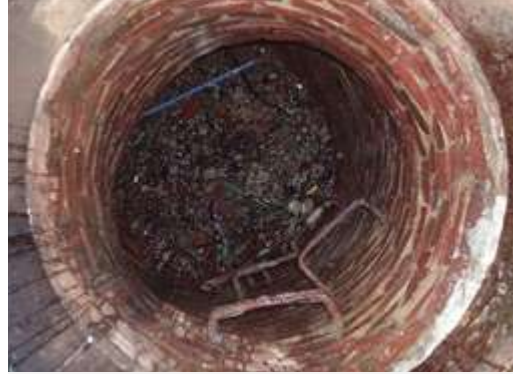
Top View

Corroded steps. Evidence of surcharge - Bench debris.

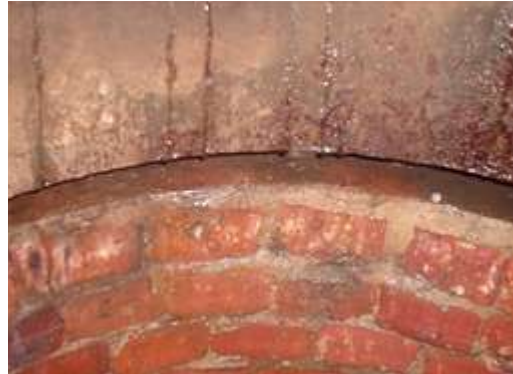
Defect

Frame leaks. Corbel infiltration.

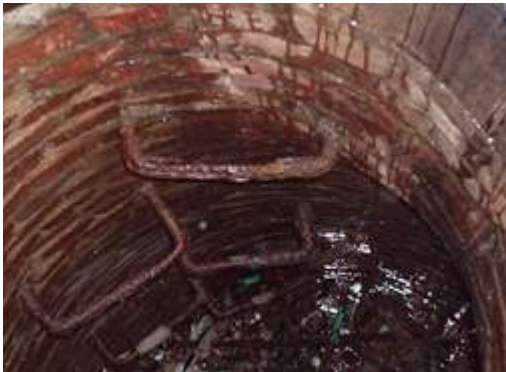
Defect

Frame leaks. Corbel and Barrel infiltration.

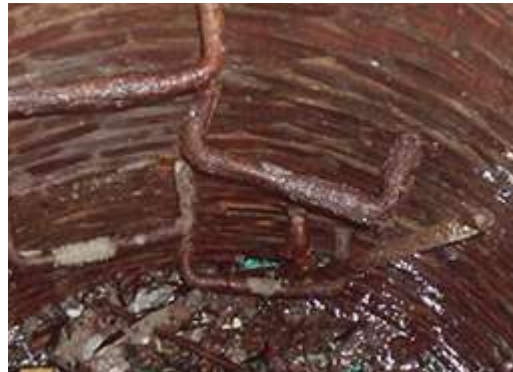
Defect

Barrel infiltration.

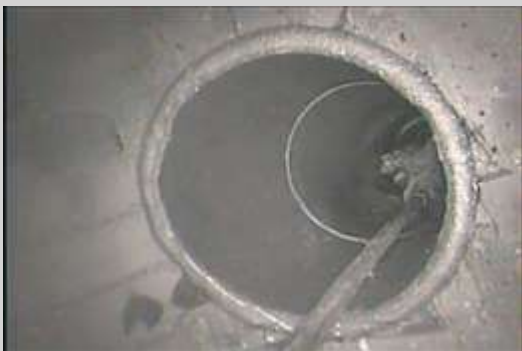
### 8 in. Circular Gravity Sewer Pipe In @ 5 O'Clock

Infiltration: **Evidence** Pipe Seal Cond: **Unknown**

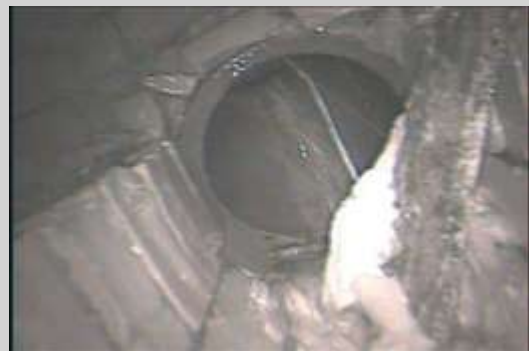
### Drop In @ 5 O'Clock

Channel debris.
